Case Study: Landslides in Ciudadela Reinaldo Espinosa, Loja, Ecuador

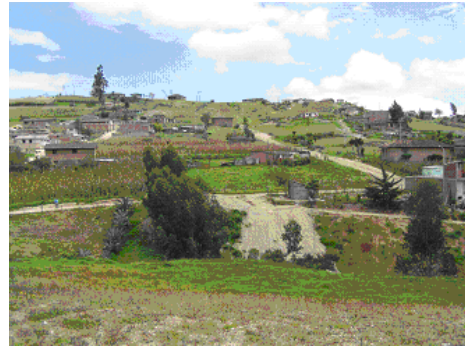
Fig. 1. Panoramic view of the unstable area in Ciudadela Reinaldo Espinosa.

The broader area around Reinaldo Espinosa is currently undergoing rapid urban growth as an extension of Loja, adding to the importance of the pilot area's technical research. This work will contribute to establishing measures of prevention and mitigation to help minimize the effects of future slides in areas beyond Reinaldo Espinosa, where the geological and geotechnical factors are comparable, and similar instability issues are likely (Fig. 1).

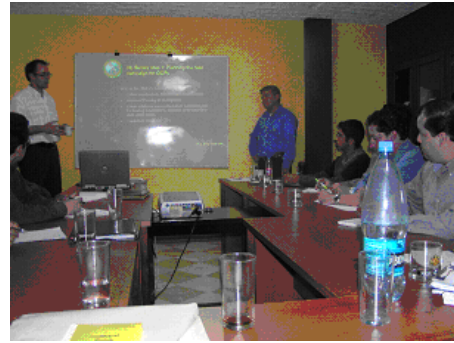
Fig. 2. Workshop on the use of differential GPS.

Work in the area took place between April 27 and May 3, 2004. The first few days included a workshop for staff of DINAGE and participating regional institutions on the use of differential GPS in the Loja offices of MEM (Fig. 2). This initial work included establishing a base station location on the roof of the MEM office building, from which all ground reference and monitoring stations were measured. This location will be used well into the future for a variety of studies. The group then proceeded to the field to apply this technique in Ciudadela Reinaldo Espinosa and along the Loja-Zamora highway.

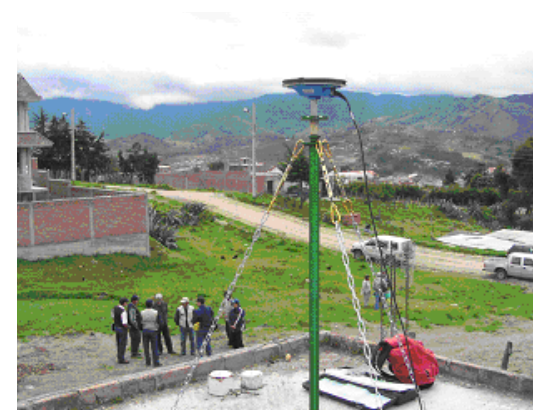
Fig. 4. Differential GPS monitoring station.

In the area of Ciudadela Reinaldo Espinosa, one monitoring station was installed, and 15 control points were measured in locations previously identified in aerial photographs (Fig. 4). A longitudinal profile was also created from the main scarp to the foot of the slide, as well as two cross sections of the affected area (Fig. 5).

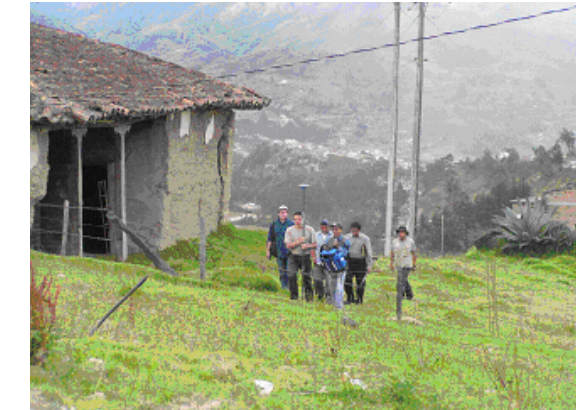
Fig. 5. Technicians creating a transversal profile in the slide area. Note steepness of slope and hummocky topography.
